UNITED STATES AIR FORCE
AIRCRAFT ACCIDENT INVESTIGATION
BOARD REPORT

F-22A, T/N 06-4125

JOINT BASE ELMENDORF-RICHARDSON, ALASKA

DATE OF ACCIDENT: 16 NOVEMBER 2010

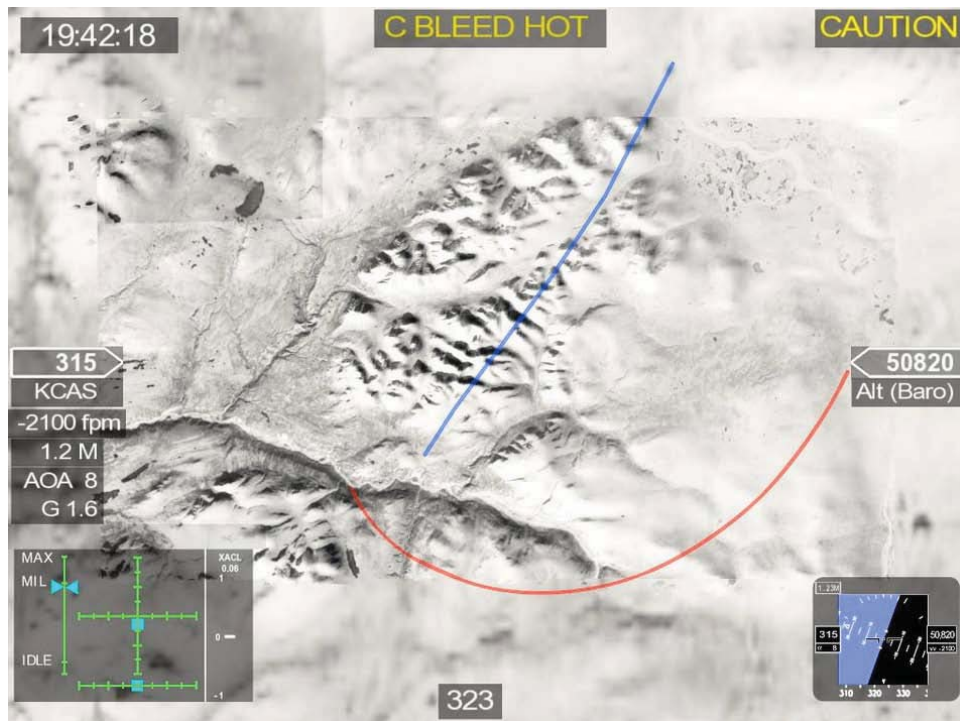
Figure 1 19:42:18L -- Relative position between MFL (blue) and MP (red) at the assertion of the C BLEED HOT caution ICAW. (Tab EE)

At 19:42:18L the fire protection system (FPS) detected a bleed air leak in the center bleed air ducting from both engines. In response to the FPS, the Integrated Vehicle Subsystem Controller (IVSC) asserted the C BLEED HOT caution ICAW while it requested the Environment Control System (ECS) to isolate the center bleed system. “CAUT” was displayed in the heads up display (HUD) advising the MP of the caution ICAW (Tab J-4). When the C BLEED HOT caution ICAW asserted, the following functions were lost:

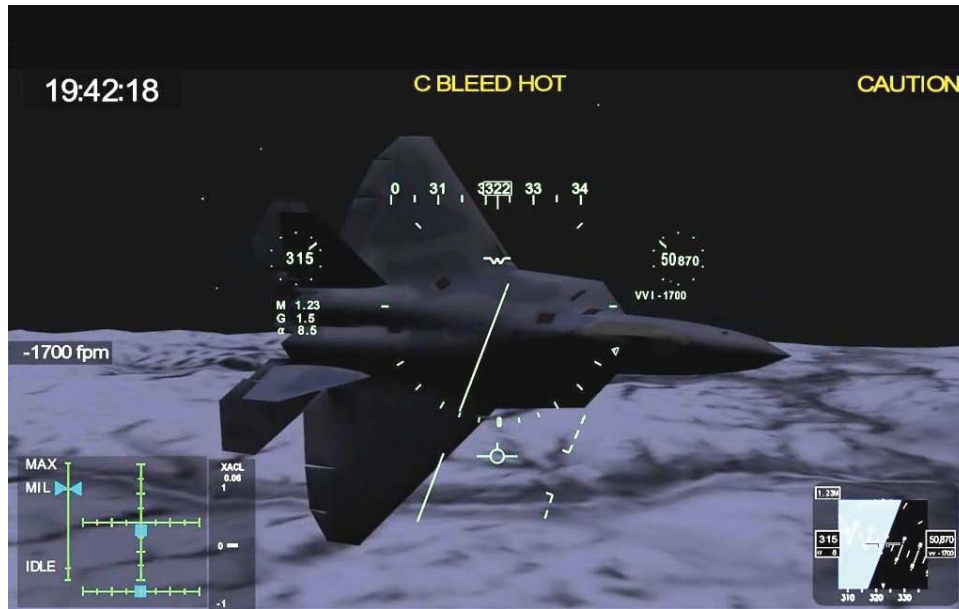
The MA was at 50,870 ft MSL, 315 knots calibrated airspeed (KCAS), 1.23 M, with an attitude of 1 degree nose up, 69 degrees right wing down (RWD), heading 323 degrees, 1.5 g, and with a vertical velocity indication (VVI) of -1,700 ft per minute (fpm). (Tab EE)

Figure 2 19:42:18 -- MA parameters at assertion of C BLEED HOT caution ICAW. (Tab EE) See Tab Z-10 for a diagram explaining the symbology in the Figures.

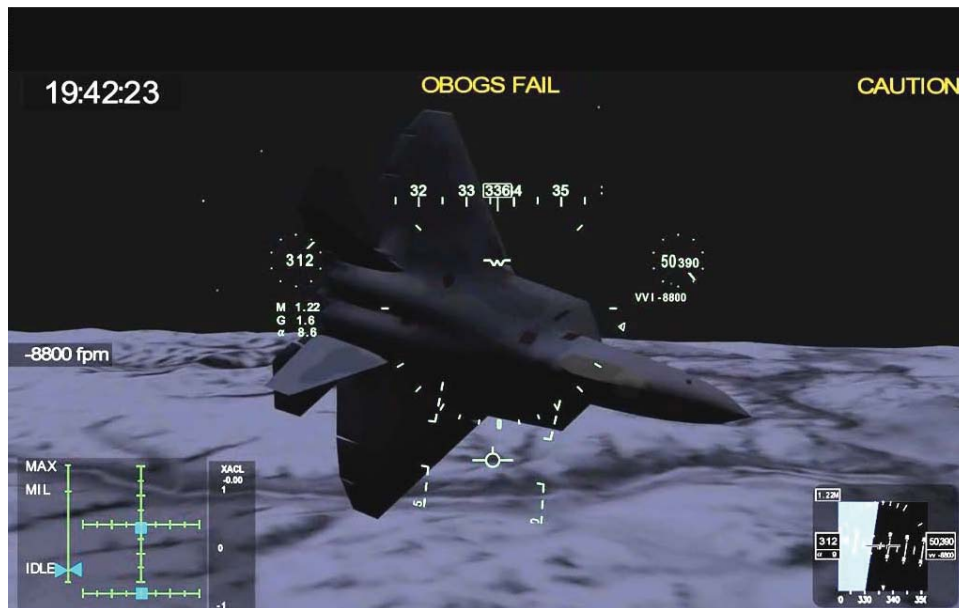
The C BLEED HOT caution ICAW cleared at 19:42:21L indicating the overtemperature condition no longer existed after the IVSC commanded the bleed air ducts to the closed position and stopped the flow of bleed air to the ECS. Due to the ECS no longer supplying pressure to OBOGS, the pressure dropped below the 10 pounds per square inch (psi) minimum threshold and displayed an OBOGS FAIL caution ICAW at 19:42:23L.

Figure 3 19:42:23 – MA parameters at assertion of OBOGS FAIL caution ICAW. (Tab EE)

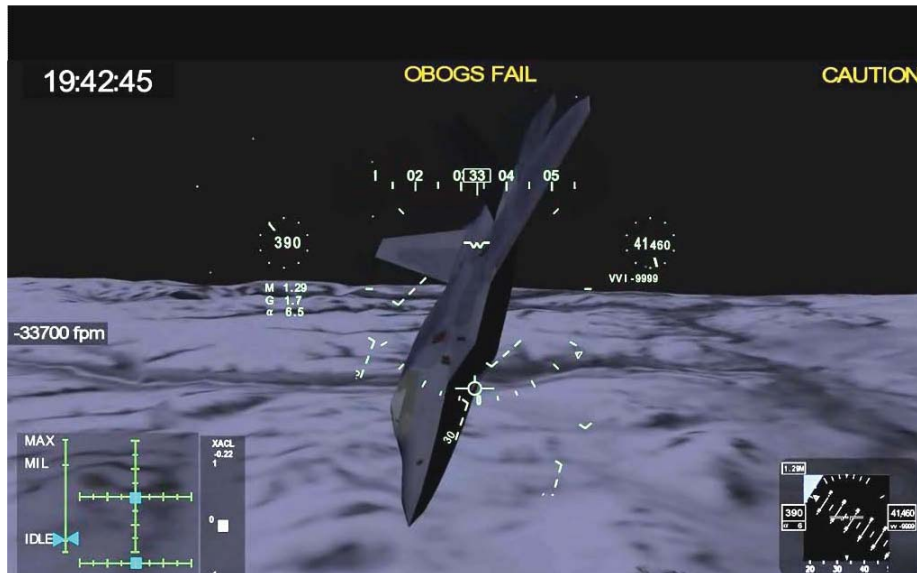
At the assertion of this ICAW until 19:42:45L, the MP retarded the throttles to IDLE power and deliberately continued a controlled, descending right hand turn to descend to a lower altitude IAW the checklist. (Tab BB-29) At this time the MA was at 41,460 ft MSL, 390 KCAS, 1.29M, 30 degrees ND, 44 degrees RWD, 1.7 g, and with a VVI of -33,700 fpm. (Tab EE)

Figure 4 19:42:45 – MP deliberately flew to a controlled attitude of 30 degrees ND and 44 degrees RWD in order to descend to a lower altitude IAW the checklist. (Tab EE)

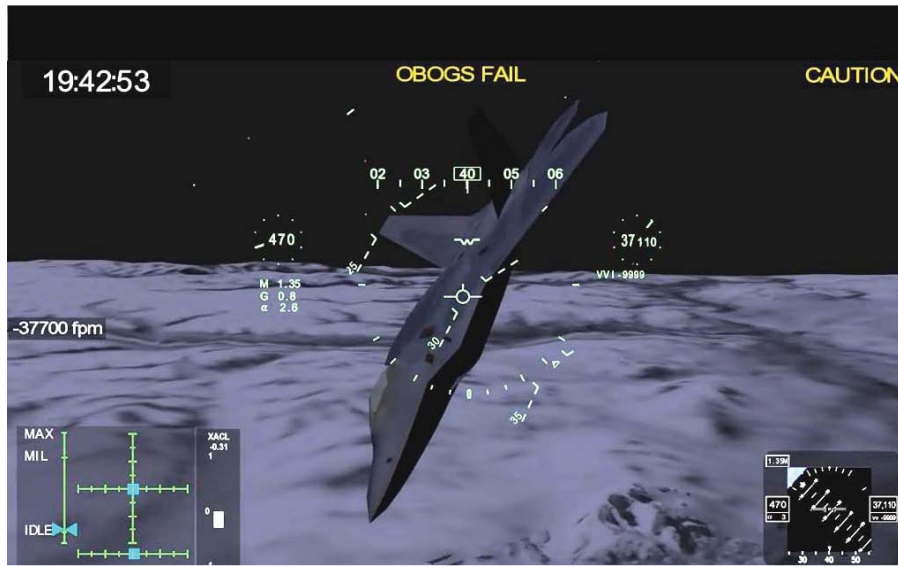
The C SMU mishap data discrete signal showed partial pressure to the MP's oxygen mask stopped shortly after 19:42:37L, which would lead to severely restricted breathing. (Tab J-43) From 19:42:45L until 19:42:53L, the MP made no inputs to the stick, pedals, or throttles, and the MA maintained a relatively stable bank angle and attitude. The MA was at 37,110 ft MSL, 470 KCAS, 1.35M, 30 degrees ND, 46 degrees RWD, 0.8 g, with a VVI of -37,700 fpm. (Tab EE)

Figure 5 19:42:53 – MA parameters after 8 seconds of zero MP inputs to stick, pedals, or throttles. (Tab EE)

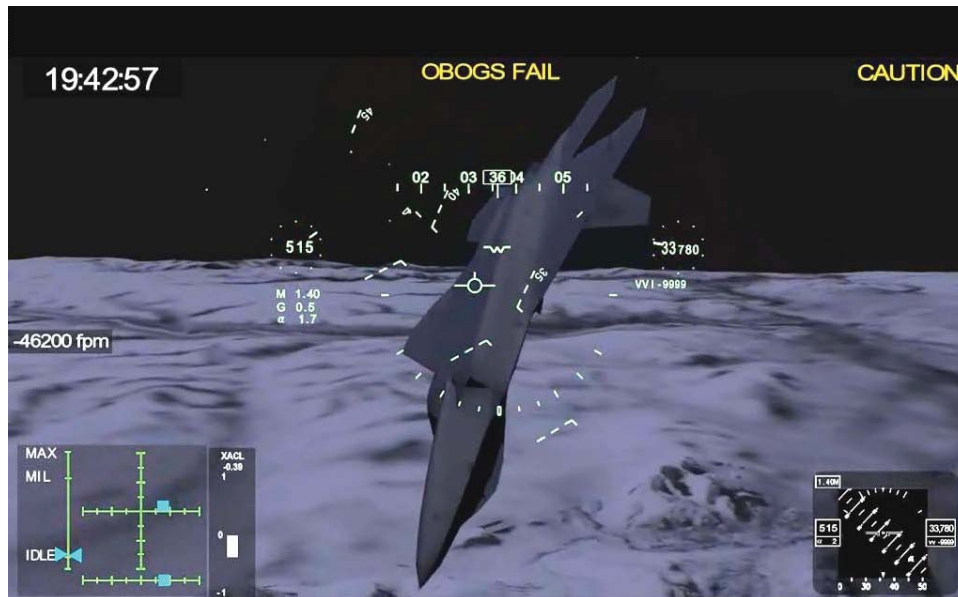
At 19:42:53L, the MP input a combination of right forward stick and right pedal which initiated a 240 degree descending right roll at greater than 45 degrees per second. (Tab EE)

Figure 6 19:42:57 – MA parameters during MA 240 degree roll to the right resulting from stick and pedal inputs. (Tab EE)

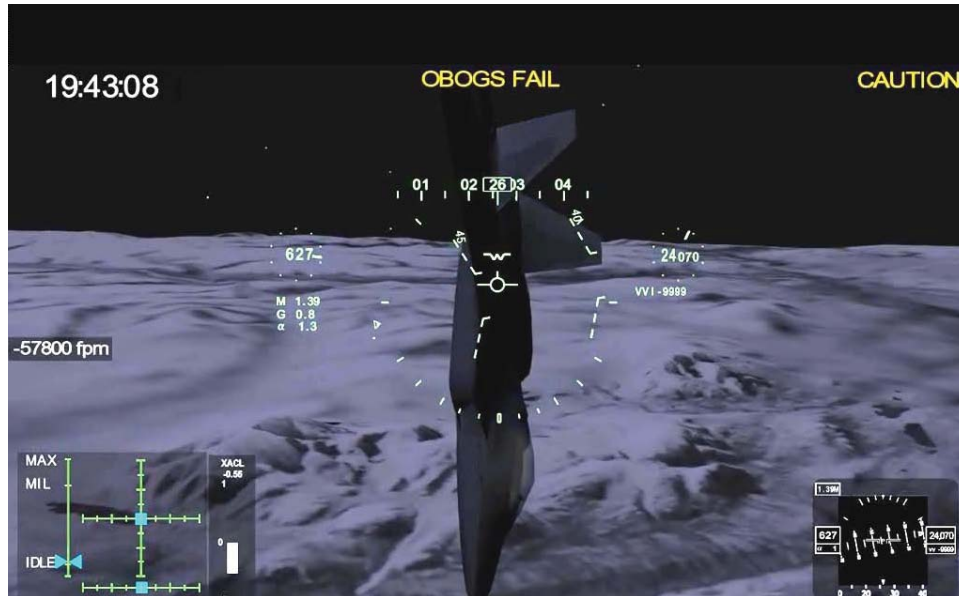
At the completion of these stick and pedal inputs at 19:43:08L, the MA had rolled through inverted, experienced less than 1 g of gravitational force, and went from a RWD to Left Wing Down (LWD) at titude, and the descent rate of the aircraft significantly increased. The parameters at this time were 24,070 ft MSL, 627 KCAS, 1.39M, 44 degrees ND, 81 degrees LWD, 0.8 g, with a VVI of -57,800 fpm. (Tab EE)

Figure 7 19:43:08 – MA parameters when stick and pedal inputs cease after the 240 degree roll. (Tab EE)

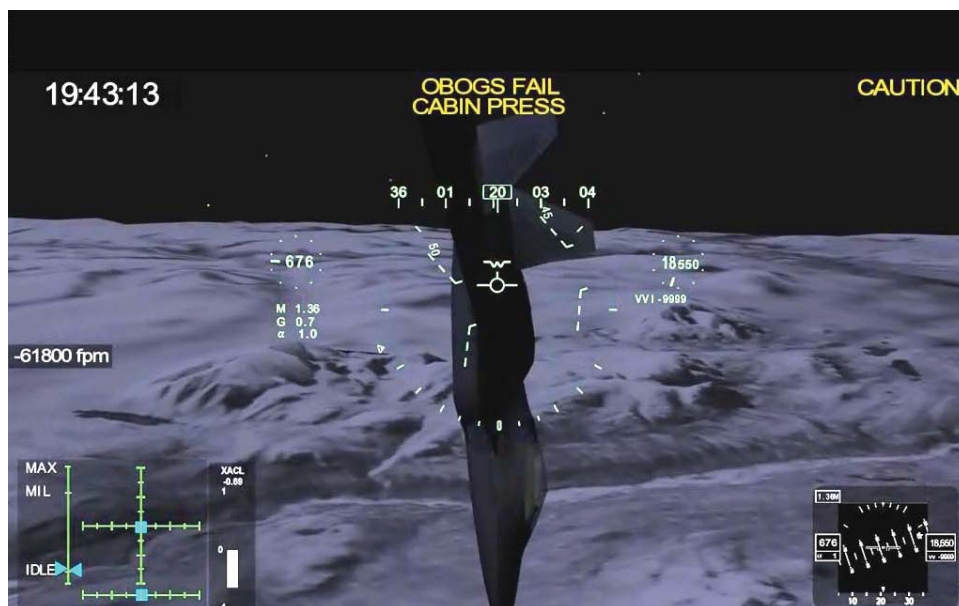
After 19:43:08L, there were no stick inputs and only very minor pedal inputs for the next 15 seconds. At 19:43:13L, passing approximately 19,000 ft MSL, a CABIN PRESS caution ICAW asserted based on cockpit pressurization exceeding its normal schedule. (Tab J-13)

Figure 8 19:43:13 – MA parameters at assertion of CABIN PRESS caution ICAW. No stick or pedal inputs. (Tab EE)

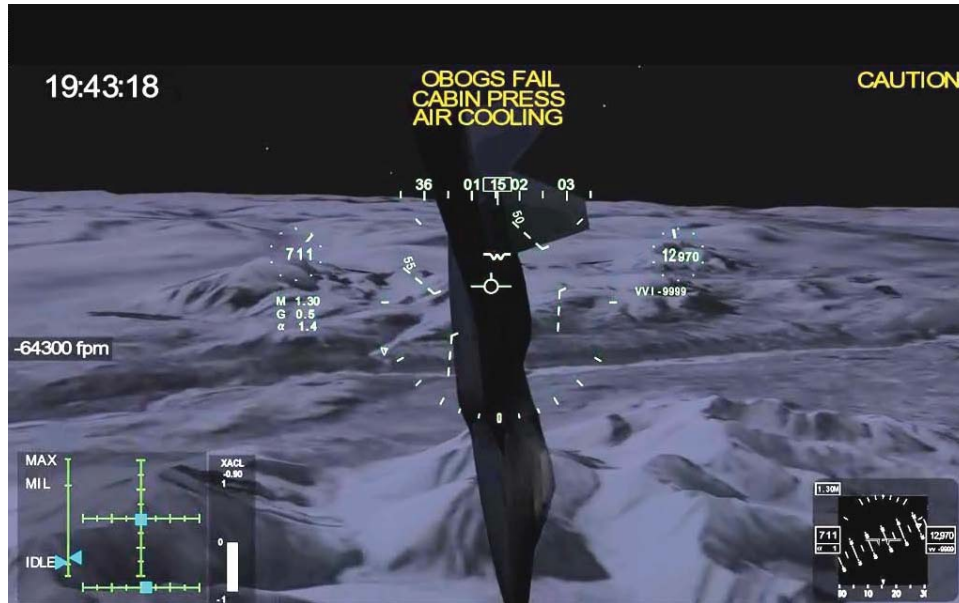
At 19:43:18L, passing 12,400 ft MSL, an AIR COOLING caution ICAW asserted. This ICAW would assert 60 seconds after a C BLEED HOT caution ICAW if the aircraft were not receiving an adequate cooling air source to its avionics. (Tab J-13)

Figure 9 19:42:18 – MA parameters at assertion of AIR COOLING caution ICAW. No stick or pedal inputs. (Tab EE)

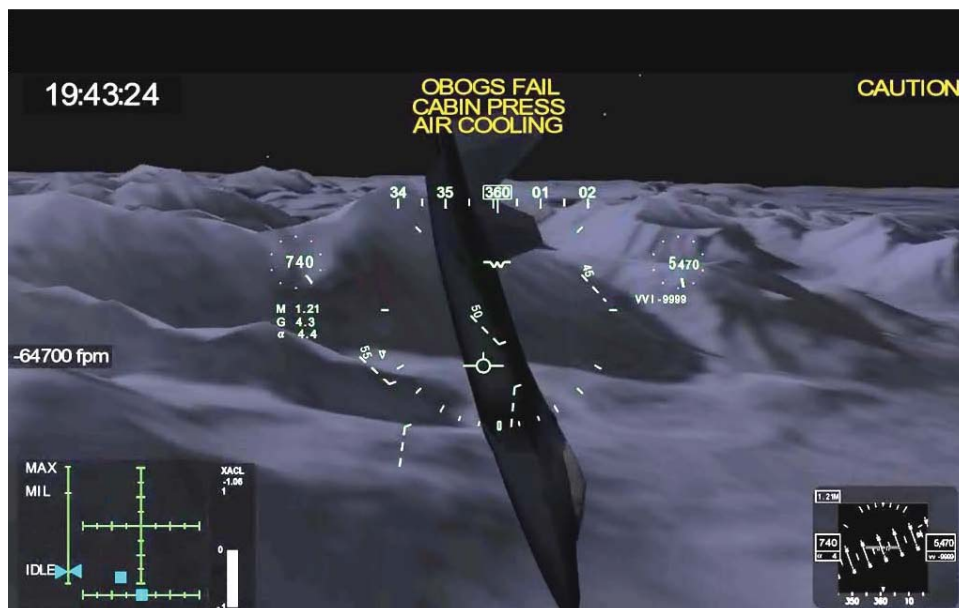
At 19:43:24L the MP performed a dive recovery at 5,470 ft MSL by pulling aft on the stick, producing a 7.4 g pull up maneuver. The MA impacted the ground 3 seconds later, inflicting fatal injuries to the MP and destroying the MA. (Tab EE)

Figure 10 19:43:24 – MP initiates full aft stick pull to start dive recovery at 5,470 ft MSL. (Tab EE)

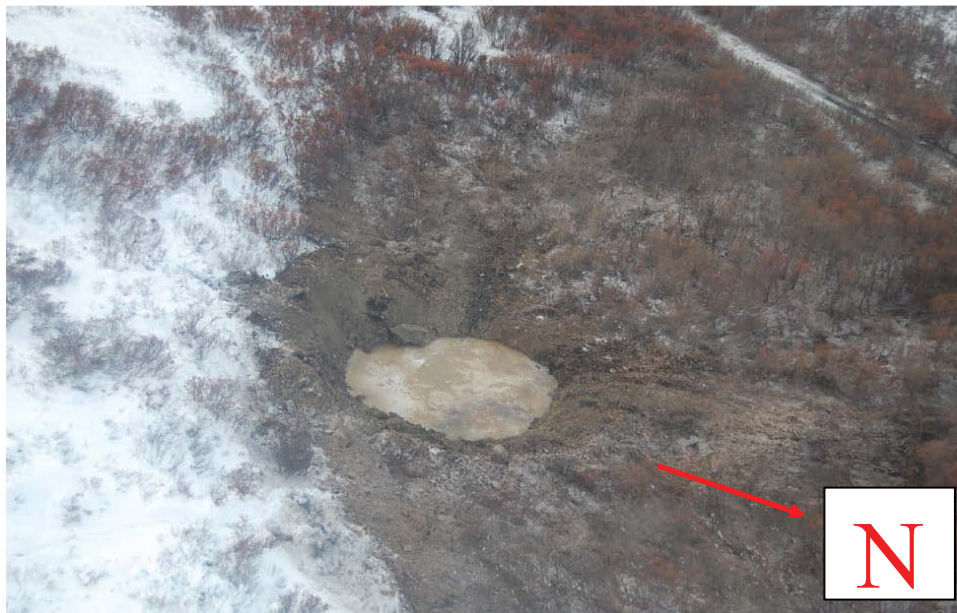
At 19:43:27L, the MA impacted the ground at 735 K CAS, 1.17M, 48 degrees ND, 47 degrees LWD, 7.4 g, with a VVI of -57,900 fpm. The impact site is approximately 120 NM north of JBER, AK, in the Talkeetna Mountain range. The site is approximately 3,100 ft MSL near the edge of a south-west to north-east running valley. The impact crater is located at the valley floor where it begins to slope upwards towards the southeast. The valley floor is approximately one-half mile wide at this point and has a stream running through it approximately 60 yards west of the impact point. (Tabs J-4 through J-6)

The debris field consisted of small aircraft and engine pieces extending approximately one-quarter mile from the crater. The upslope wall of the crater and aircraft impact angle appear to have focused the debris pattern in a 60 – 80 degree wide arc from west to north. (Tabs J-4 through J-6)

Figure 11 Impact Crater 17 Nov 2010 (Tab S-7)

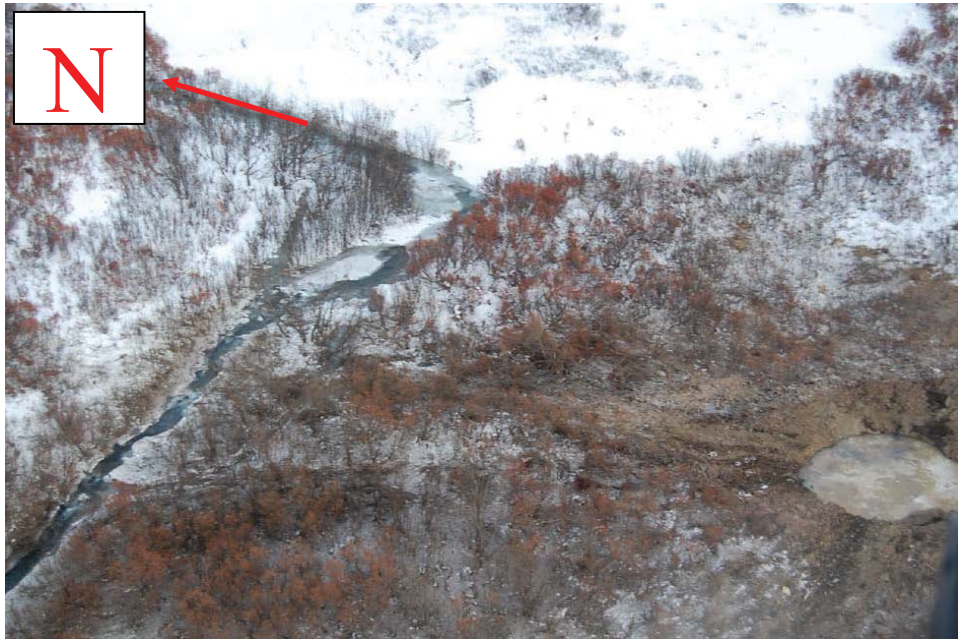
Figure 12 Impact Site. 17 Nov 2010 (Tab S-7)

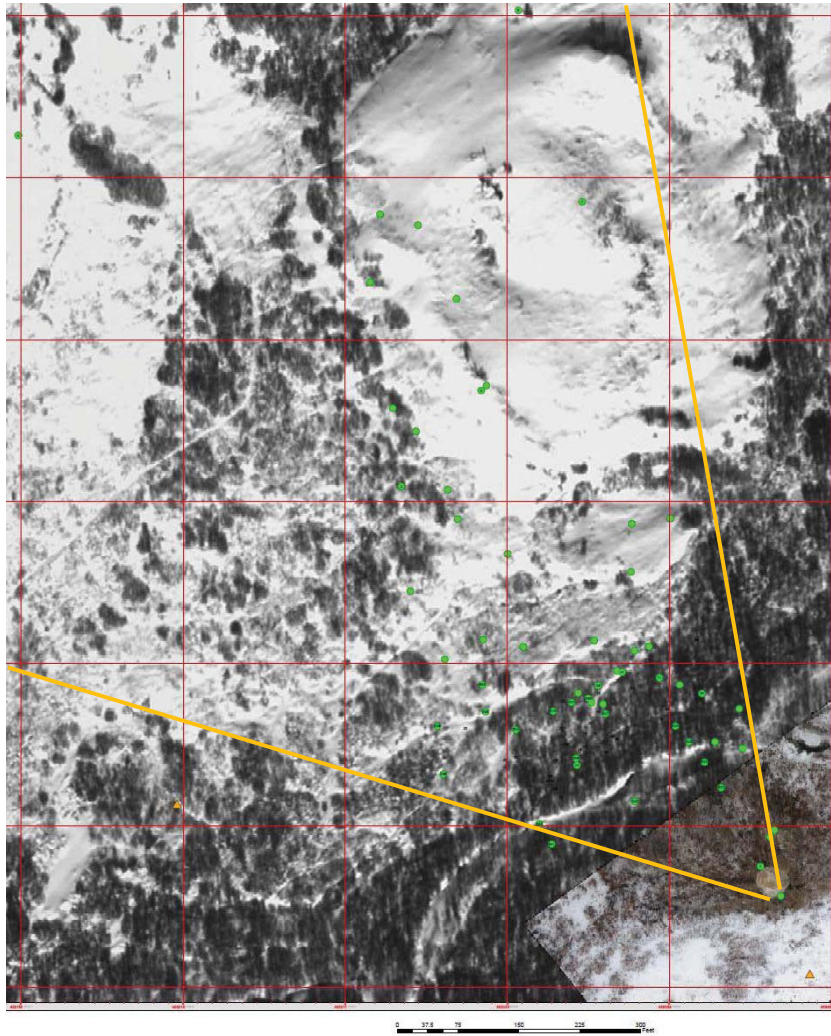
Figure 13 Aircraft Parts Scatter Diagram. Parts represented by green dots. (Tab S-4)

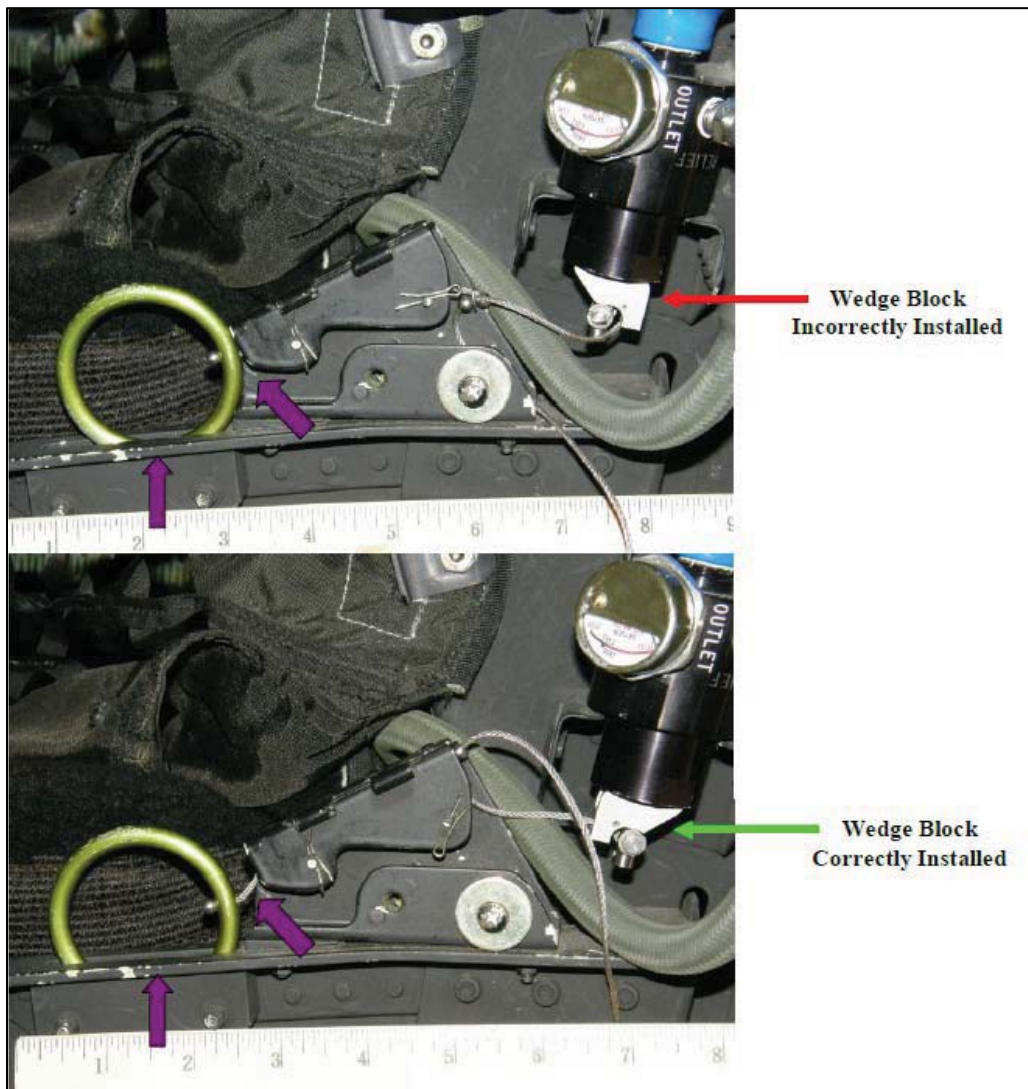
The AFRL report identified that if the EOS wedge block had been incorrectly installed, the wedge block would be unable to move or rotate during manual EOS ring activation. However, during ground simulation the board members were able to initiate the EOS in the incorrectly installed position. (Tab U-4)

Figure 14- The wedge block installed incorrectly (red arrow) and correctly (green arrow). Notice the position of the ring within the seat (purple arrows) based on wedge block position. (Tab Z-6)

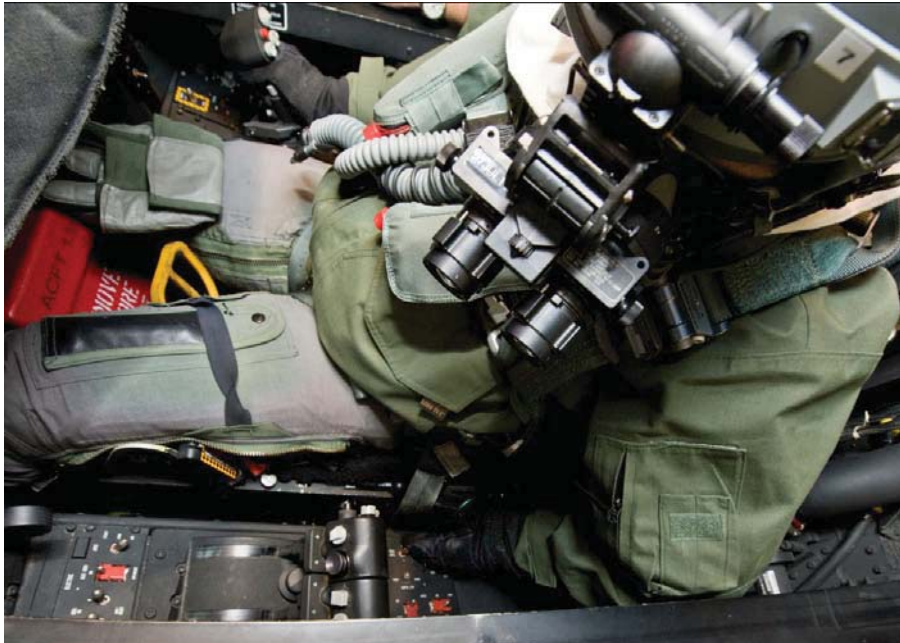
Figure 15 - Pilot pulling EOS activation ring. NVG interfering with EOS ring visualization. (Tab CC-5 and Tab Z-7)

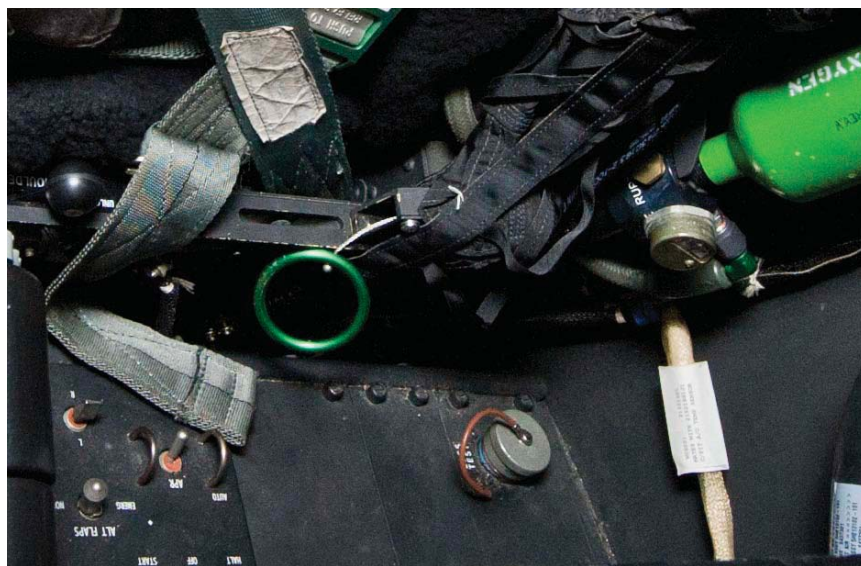
During ground simulation, the manual EOS activation ring was unseated and dropped between the seat and console prior to EOS activation. This was done to simulate a failed initial pull,

which may have occurred for various reasons, including: the EOS activation ring was dropped or the EOS cable jammed during an attempted manual activation. Retrieval of the ring from between the seat and console would be difficult based on the seat position, night environment, and with personal equipment interference (as discussed in the next section). (Tab CC-5)

Figure 16- Manual EOS activation ring fallen below lip of seat. (Tab CC-5 and Tab Z-8)

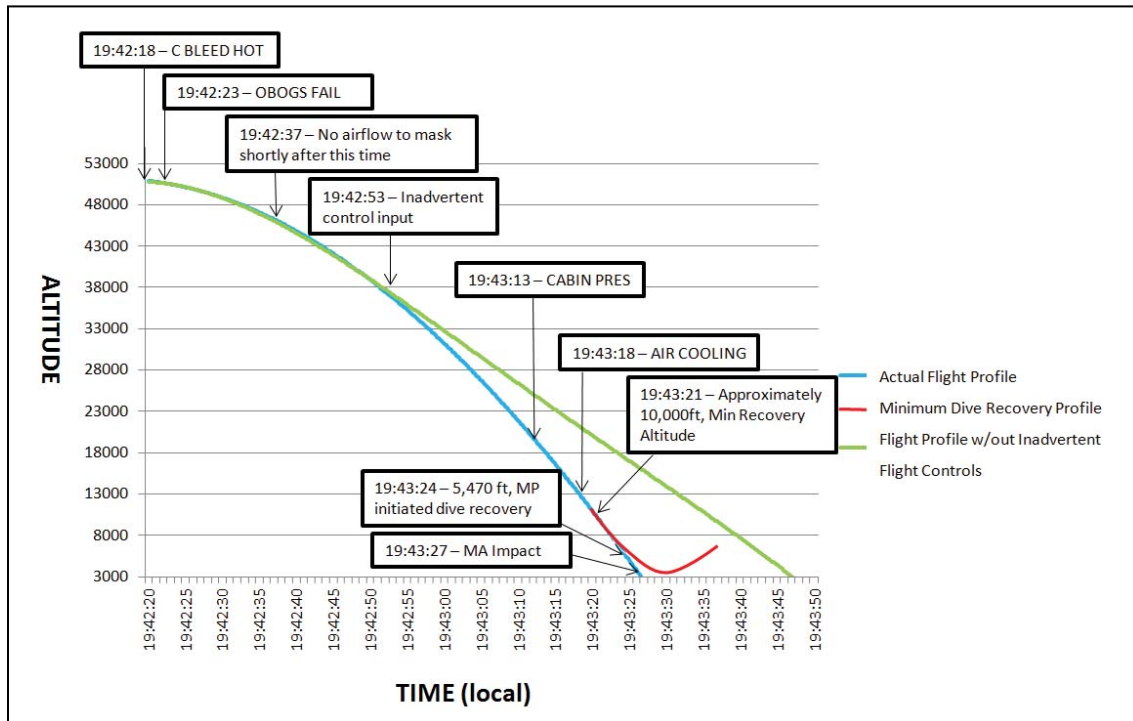
Fifth, the MP was late to recognize the necessity for a dive recovery. At 19:43:27L, the MP impacted the ground because his channelized attention and breakdown in visual scan resulted in unrecognized spatial disorientation. When the MP recognized the MA attitude and altitude, he was below minimum recovery altitude. Figure 17 shows the actual initiation of the attempted dive recovery altitude along with the 1F-22A-1 minimum recovery altitude.

Figure 17 Flight profiles for MS. Actual flight profile (blue), minimum altitude dive recovery profile (red), and flight profile without inadvertent flight control inputs (green) shown.
